2020 Flood Events:
Flood and Water Management Act
Section 19 - Investigation
Church Lane, Marchington

Flooding at Church Lane road bridge, Marchington

Document Ref:			2020 Flooding: Section 19 Flood Investigation for Church Lane, Marchington		
Revision	Date	Description	Originated	Checked	Authorised
0	11/08/2022	Draft for RMAs	Caroline Parkin	-	-
1	31/10/2022	RMA Comments incorporated	Caroline Parkin	Chris Archer	-
2	19/01/2023	Comments from ESBC incorporated	Caroline Parkin	Jamie Cooper	Jamie Cooper

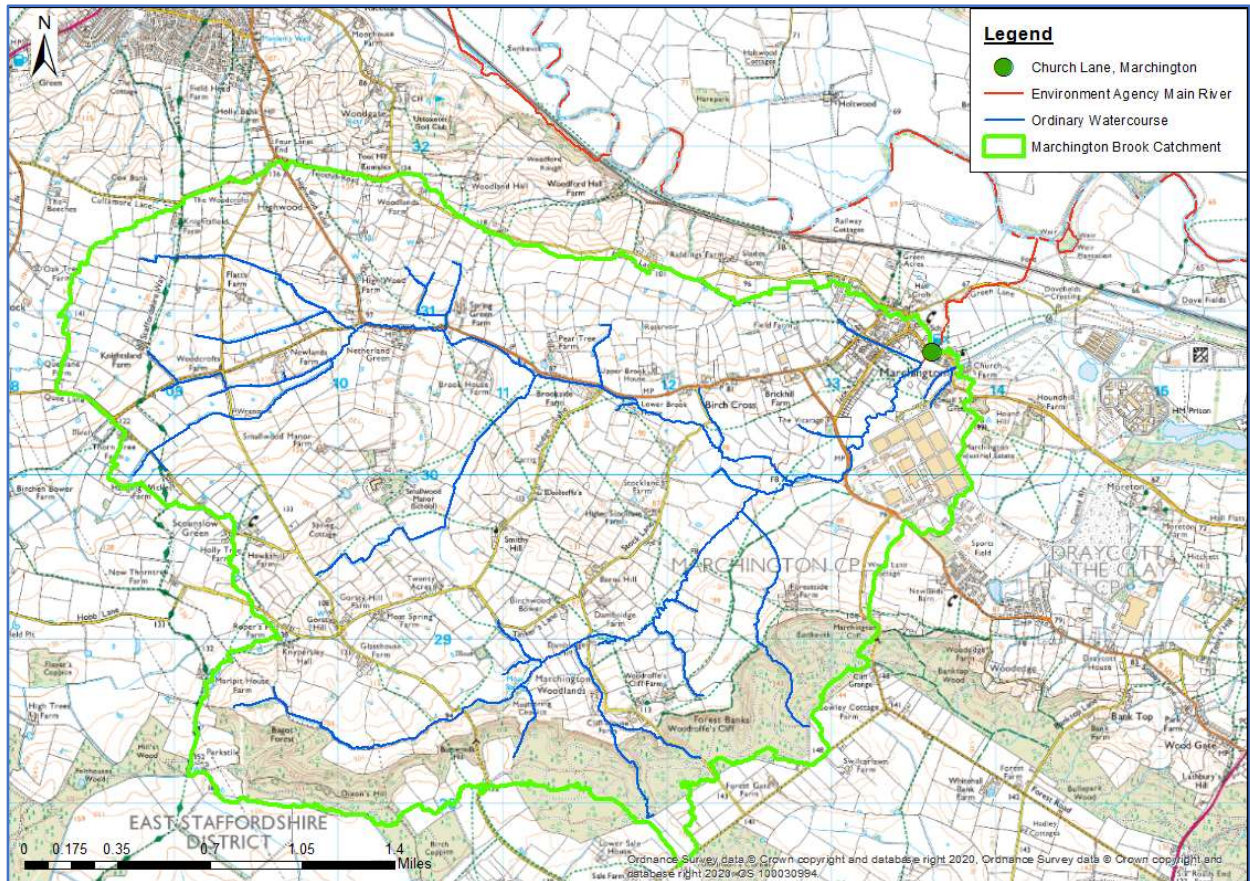
Figure 7: Marchington Brook Catchment

Marchington Brook drains a catchment area of approximately 16km² (Figure 7). The catchment is predominantly rural, with the surrounding area comprising arable and grassland with some woodland areas. The catchment is steep, particularly in its upper reaches at Marchington Cliffs, and responds quickly to heavy rainfall events. The underlying geology at the flood location is dominated by the Mercian Triassic Mudstone group, comprising moderately permeable clays and mudstones. Overlying superficial drift deposits are found adjacent to the watercourse and comprise mud, sand and gravels. Such deposits can exhibit high water tables, particularly in times of high flow and when the ground is saturated.

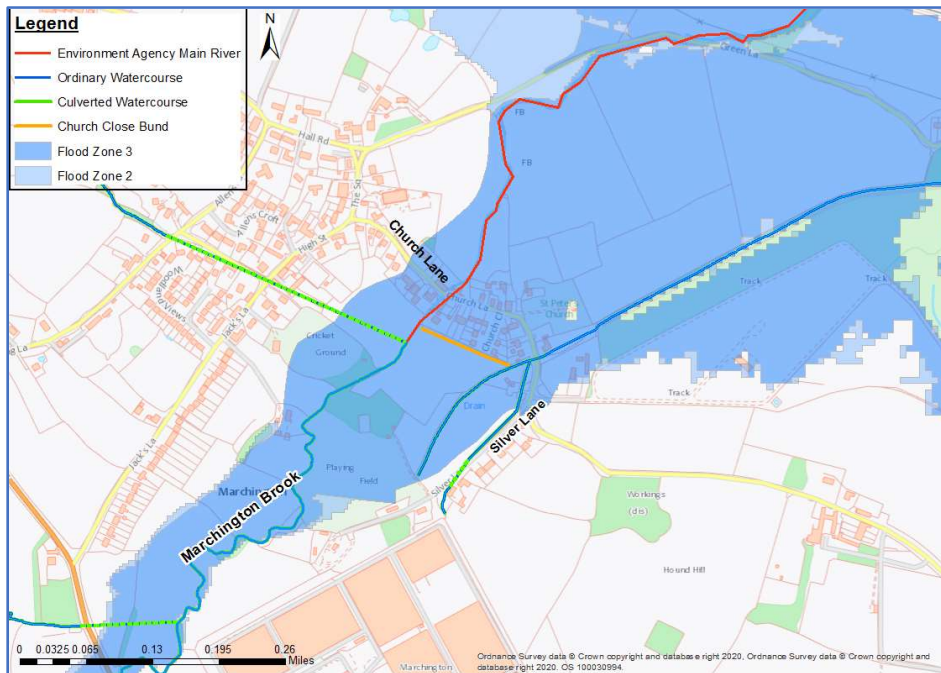
Figure 8: Environment Agency Risk of Flooding from Rivers and Sea (RoFRS) map demonstrating Flood Zones 2 and 3 at Church Lane, Marchington

Church Lane is at risk of flooding from multiple sources. Figures 8 and 9 below demonstrate the Environment Agency's Flood Zones from Rivers and Sea (RoFRS) and the Risk of Flooding from Surface Water (RoFSW) maps for Church Lane, Marchington.

The Environment Agency's Flood Zone map clearly shows the risk of flooding to Church Lane from Marchington Brook, with large parts of the road located within both Flood Zones 2 and 3 (Figure 8). Areas both upstream and downstream of Church Lane are also shown to be at risk.

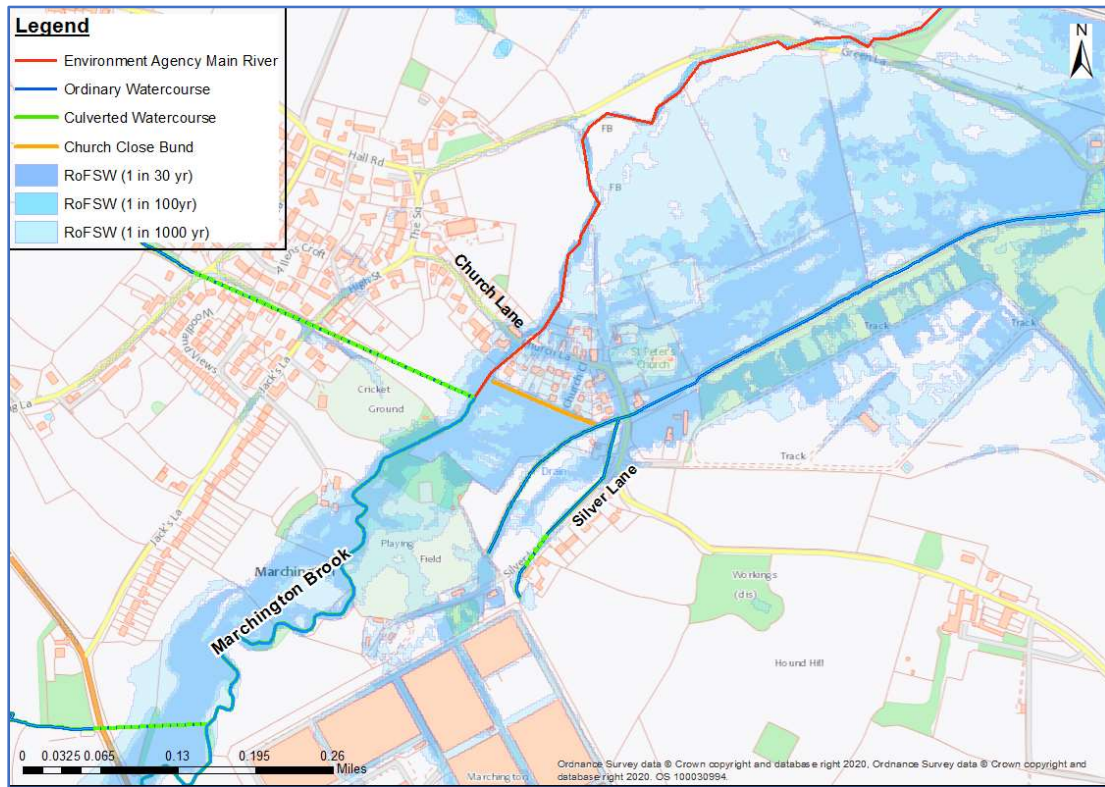
Figure 9: Environment Agency Risk of Flooding from Surface Water Maps for Church Lane, Marchington

Review of the RoFSW maps (Figure 9) also shows a risk of surface water flooding to properties at Church Lane. Church Lane is located within the 1 in 30 year RoFSW, 1 in 100 year RoFSW and the 1 in 1000 year RoFSW maps. Comparison of the maps to anecdotal records of past flood events show a similar extent of flooding, with flow paths along both Church Lane and Church Close clearly demonstrated.

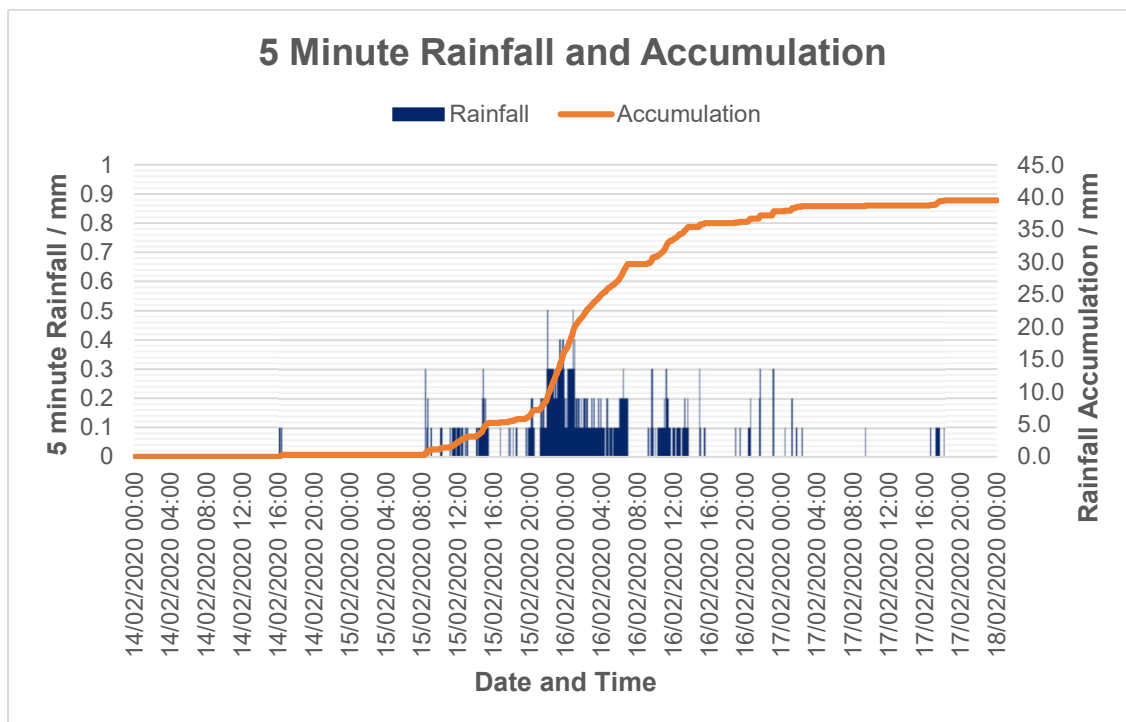
Figure 10: 5-minute Rainfall data for Church Lane, Marchington, from February 14th 2020 to February 18th 2020 (Source: Hydromaster)

Figure 10 shows the recorded 5-minute HydroMaster rainfall data for Marchington. A total of 37.5mm of rainfall was recorded over the 24 hour time period 15th February 2020 to 16th February 2020. There were several shorter periods of rainfall prior to a more significant period of rainfall which started around 21:10 on the 15th February. Of the total rainfall recorded during the event, 22.5mm was recorded during a 17-hour period between 21:10 on February 15th and 07:00 on 16th February 2020 demonstrating that the storm was intense with rainfall falling continuously throughout the duration of the storm.

The intense period of rainfall prior to the flooding incidents that occurred across the County resulted in significant volumes of surface water flowing over what was already saturated ground.

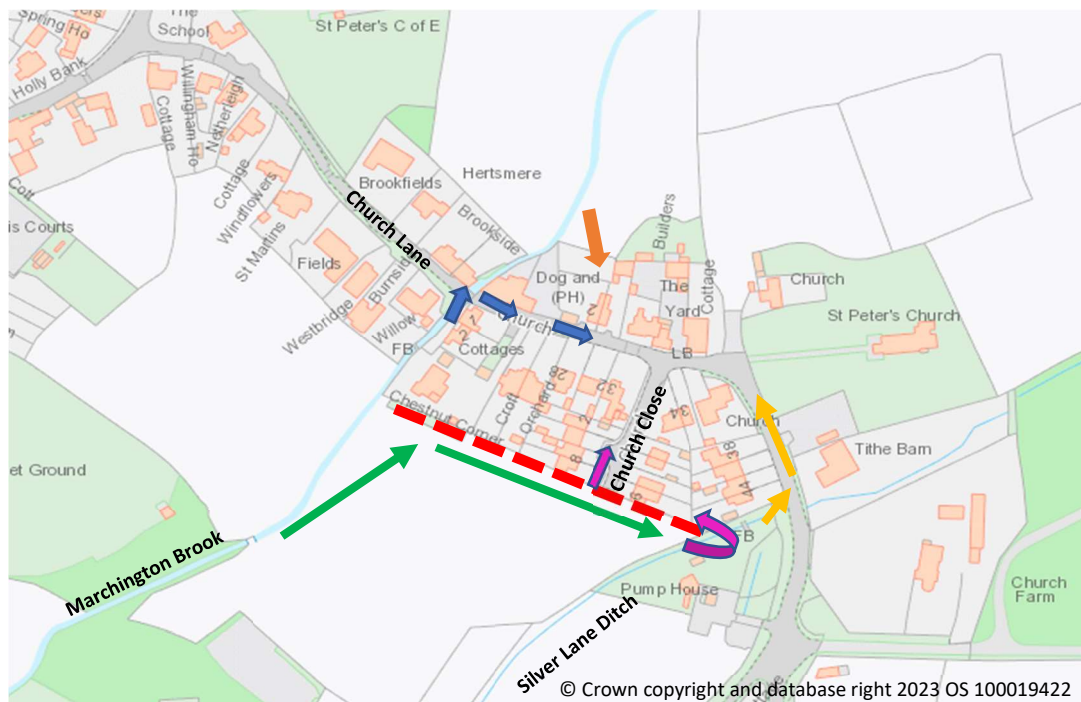
Figure 11: Observed flow routes at Church Lane, Marchington

Flooding at Church Lane is complicated as the area is low lying and flood water can surround properties from several directions. Flood water also struggles to drain down quickly when levels in the Marchington Brook and River Dove remain high. During the February 2020 event, the catchment was already saturated and river levels were elevated following a sustained period of prolonged rainfall leading up to the event. Flood water was therefore unable to infiltrate into the ground and overwhelmed watercourses and the local drainage network.

Figure 11 demonstrates the main observed flow routes at Church Lane with the following sections describing these in more detail.

During the February 2020 event, flooding to property situated towards the eastern edge of the village was also reported. Floodwater was observed spilling from the left bank of Silver Lane ditch onto the road, flowing down the road towards the village (Figure 11, yellow arrow). The ditch receives surface water flows from Marchington Industrial Estate, situated to the south. Flows from the Industrial Estate enter the ditch via a 900mm culvert pipe and then flow parallel to Silver Lane. The ditch is then culverted through two 900mm circular culverts beneath Silver Lane/Church Lane. Flooding to properties at this location occurred as a result of the high volume of water in the channel that backed up behind the culverts, spilling onto adjacent land and following the prevailing topography down Church Lane towards the lowest point in the village at the Post Office. Past site investigations have shown that the ditch course is unmaintained and open to livestock through its length, leading to some parts of the bank collapsing.

A further identified flow route is downstream of Church Lane road bridge. Anecdotal reports from residents also describe water spilling from the right bank of Marchington Brook downstream of Church Lane bridge. Water was observed flowing across the fields towards the Dog and Partridge public house into the gardens behind properties on Church Lane (Figure 11, orange arrow). The prevailing topography directs flood water from the brook towards the gardens of properties on Church Lane and onto the road itself.

- Closing of the gap by Church Lane road bridge to reduce the risk of flooding during lower order events (1 in 2 year event).
- Repairs / enhancements to the Church Close embankment.
- Clearing of culverts on Church Lane to improve the flow of water.
- Property Flood Resilience (PFR)

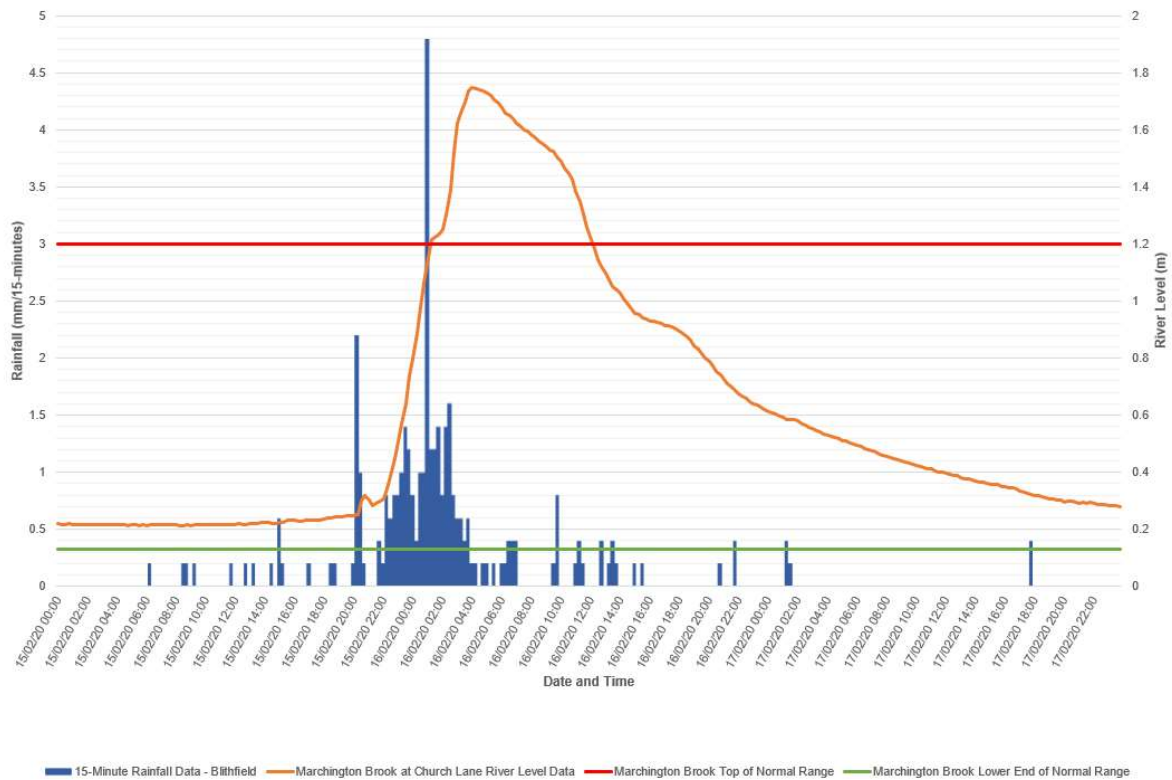
Figure 12: Recorded river level data for the Marchington Brook during the Storm Dennis event on 15th and 16th February 2020 (Data Source: Environment Agency)

Figure 12 overleaf shows that there were two 15 minute periods of exceptionally intense rainfall on 15th February at 20:00 and 01:45 on 16th February. The Environment Agency has a continuous water level gauge on the Marchington Brook located directly upstream of Church Lane. Environment

Agency recorded river level data show that these two intense periods of rainfall triggered a rise in Marchington Brook levels, and at 04:00 on the 16th February, the river gauge at Marchington recorded the third highest level since the installation of the river gauge in 2000, peaking at a level 1.75m (Figure 12). The water from the brook, combined with the accumulation of surface water resulted in flooding to properties along Church Lane. In addition, given the high water levels in the brook, the local surface water drainage system was unable to discharge into the river, resulting in surcharging of drains and surface water flooding to the highway.

Discussions with representatives from the Environment Agency indicate that modelling work undertaken following the storm has estimated that the event corresponded to an event with a 3.33% Annual Exceedance Probability (AEP), or a 1 in 30 year chance of occurring.
